This spreadsheet performs screening level calculations to estimate the effect of peeling leaded paint on the average concentration of lead in yard soil
3322 Gilpin St.

Property ID: 177	Date: 8-18-05
Address: 3322 GILPIN STREET	Telephone #:
Owner:	CO Certification #: 12860
Inspector/Assessor:

LBP Assessment Results

SITE NAME: VASQUEZ BOULEVARD AND I-70

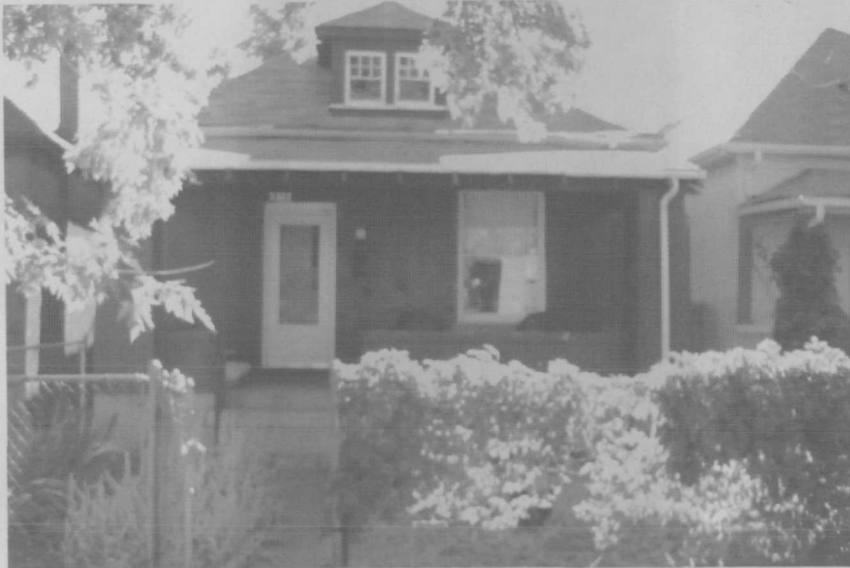
West exposure of house

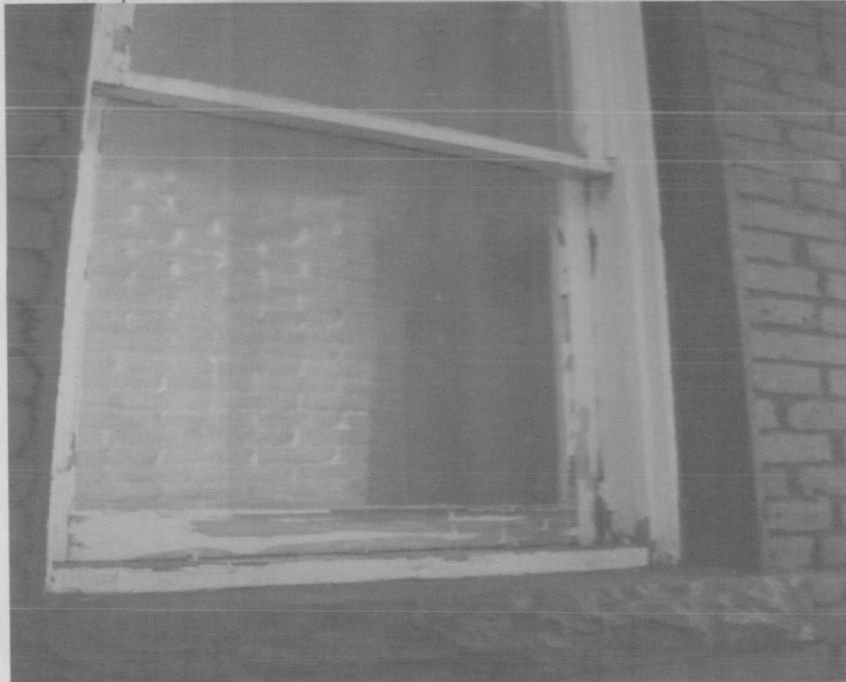
North wood window contains peeling lead paint

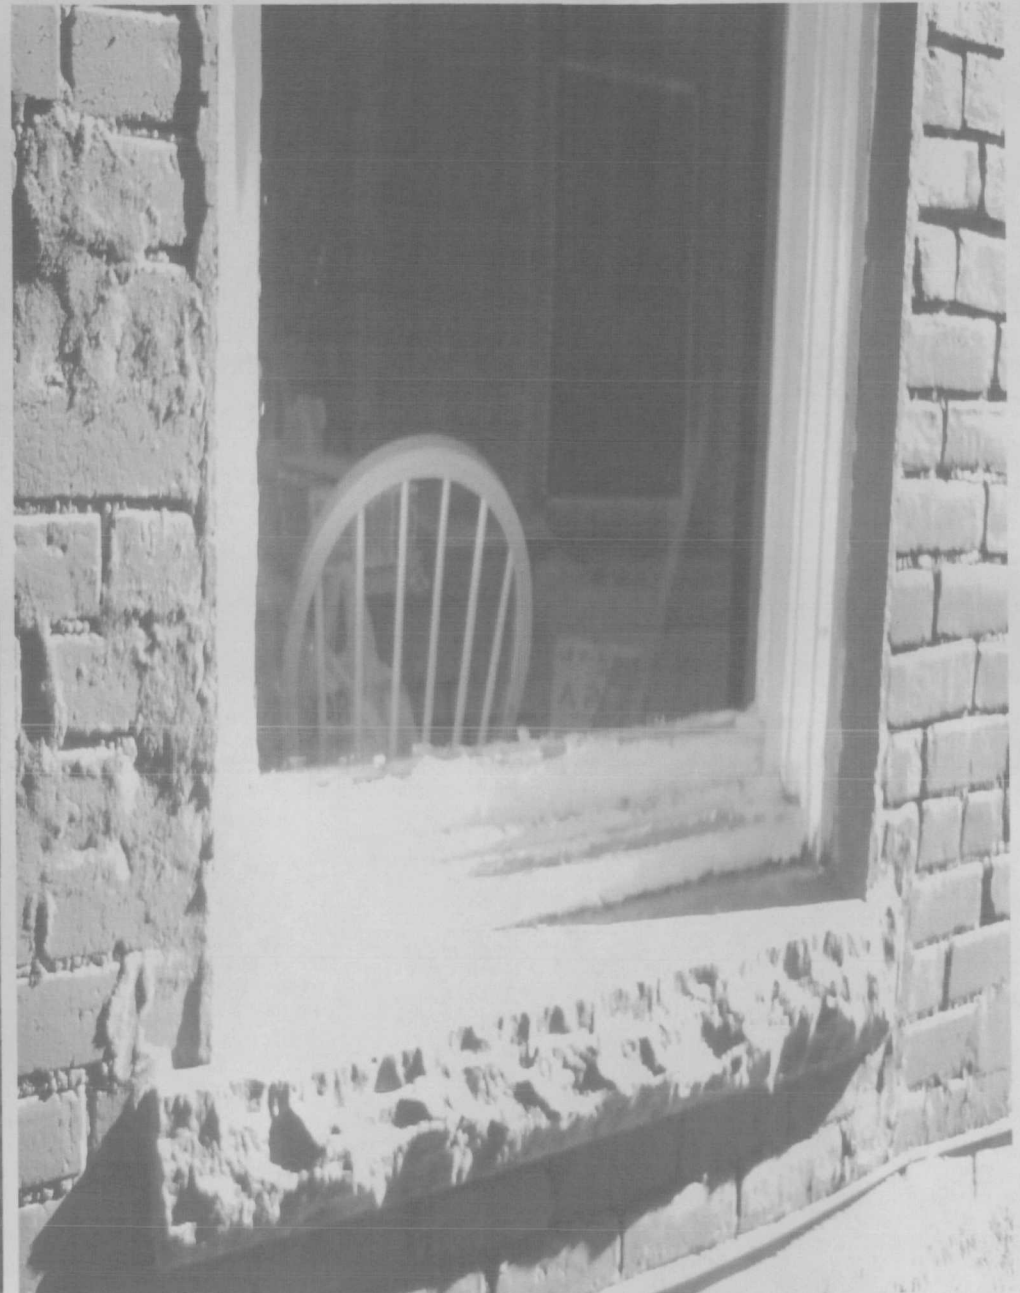
South wood window contains peeling lead paint
